Manhole Inspection Summary

Manhole # S29U__006MH

Location Address: **2100 HAINES ST**

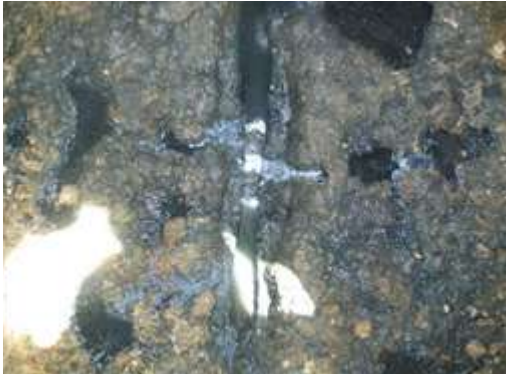
Defect3

Surcharge ☒ **Evidence Of Surcharge** Depth: **3** (ft.) ☐ Active Surcharge Present

surcharge evidence

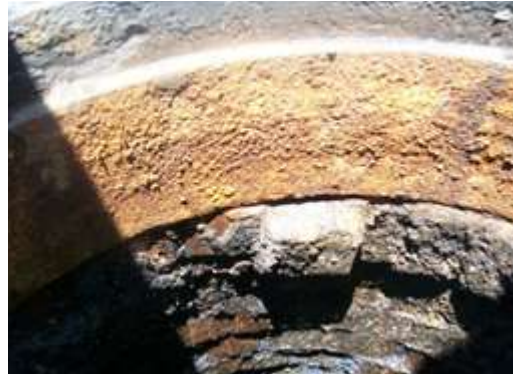
Defect 2

Condition: ☐ Sound ☐ Cracked ☐ Root Intrusion ☒ **Loose Brick** ☐ Deteriorated

LOOSE CHIMNEY BRICKS

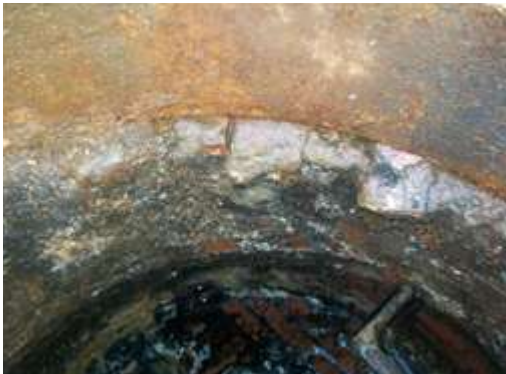
Defect 1

Frame Offset: **1.5** (in.) Condition: ☒ Sound ☐ Cracked ☐ Leaks

FRAME OFFSET

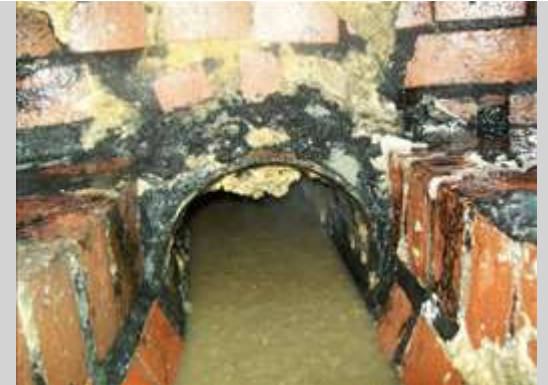
12 O'Clock Outflow

8 in. Circular Gravity Sewer
Pipe Out @ 12 O'Clock

Pipe Height: **8.4** (in.) Rod and Bar (Angled)
Pipe Material: **Clay** ☐ Pipe Lined
Invert Depth: **6.00** (ft.) Flow Characteristics: **Slow**
Deposits: ☐ None ☐ Mud ☐ Sludge ☐ Debris ☒ **Grease**
Silt Depth: **1** (in.) Deposits Extent: **Light**
Infiltration: **None** Pipe Seal Cond: **Sound**

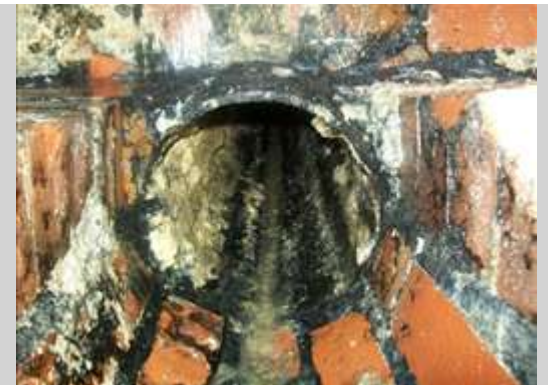
6 O'Clock Inflow

8 in. Circular Gravity Sewer
Pipe In @ 6 O'Clock

Pipe Height: **8.4** (in.) Rod and Bar (Angled)
Pipe Material: **Unknown** ☐ Pipe Lined
Invert Depth: **5.90** (ft.) Flow Characteristics: **Slow**
Deposits: ☐ None ☐ Mud ☐ Sludge ☐ Debris ☒ **Grease**
Silt Depth: **2** (in.) Deposits Extent: **Medium**
Infiltration: **None** Pipe Seal Cond: **Sound**
